"Full" Reserve Study

South Island Plantation Georgetown, SC

Report #: 34521-0
For Period Beginning: January 1, 2019
Expires: December 31, 2019

Date Prepared: December 7, 2018

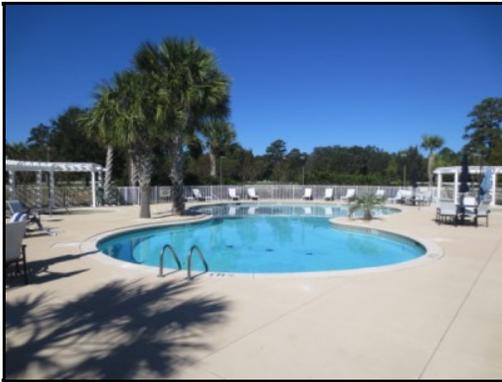
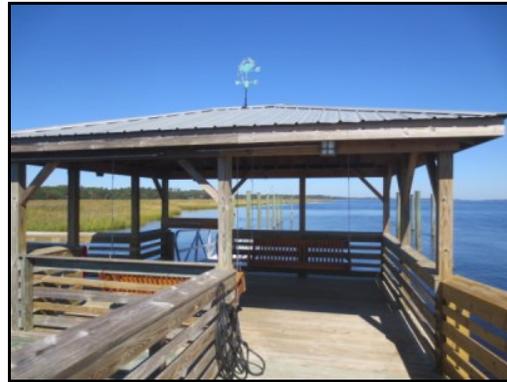
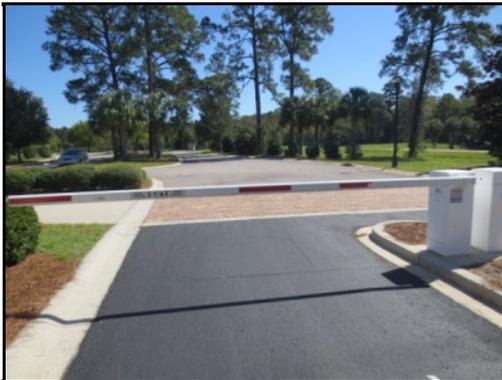
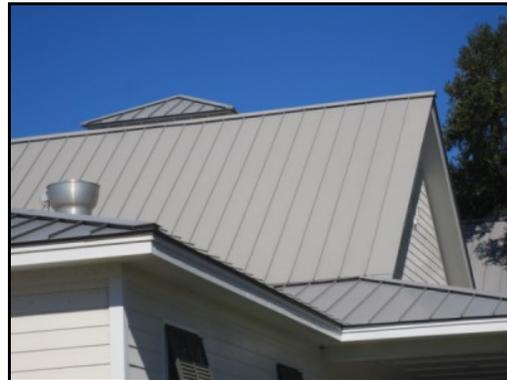
During our site visit on 10/13/2018, we were able to see most components. This is a unique association as many components are aging and the reserves have not been a focus. Many of the amenities however were in fair to good condition as there has been minimal use. Some larger refurbishment projects were discussed in the coming years. Any of these costs and scope of work should be added to future reserve studies. We visually inspected all the buildings. We were not able to inspect the fire system, building electrical and plumbing. Some of these components are outside of the scope of a reserve study.

During our site inspection we were informed that smaller repair projects are being handled from the Operational maintenance budget, not Reserves.

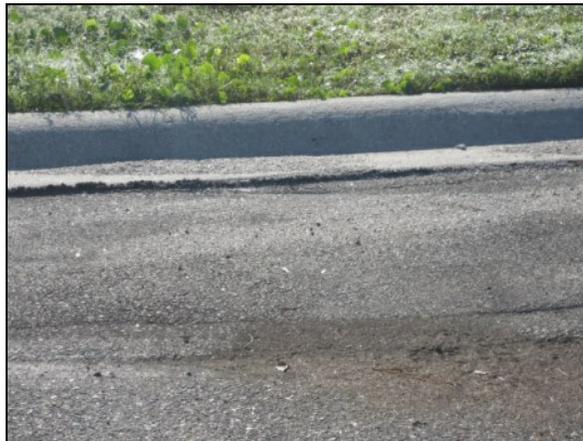
Comp #: 2107 Concrete Sidewalks - Repair

Useful Life:
7 years

Remaining Life:
5 years
