"Full" Reserve Study

South Island Plantation Georgetown, SC

Report #: 34521-0
For Period Beginning: January 1, 2019
Expires: December 31, 2019

Date Prepared: December 7, 2018

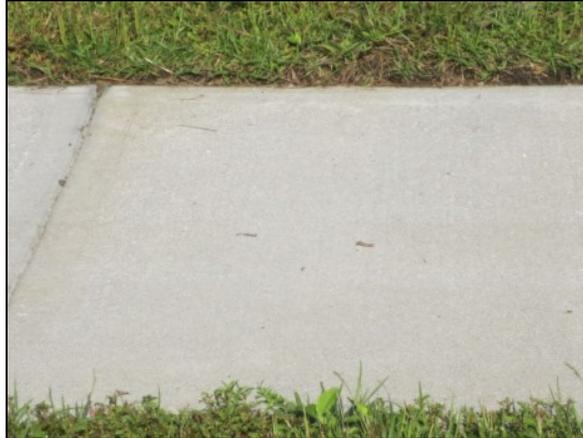
Comp #: 2107 Concrete Sidewalks - Repair

Useful Life:
7 years

Remaining Life:
5 years

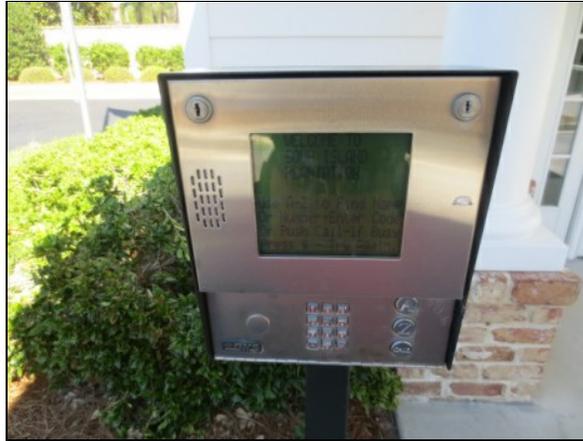
Comp #: 2501 Intercom - Replace

Comments: DKS intercom systems were noticed to be functioning. Exact age of component is unknown, RUL has been estimated. Should be checked and repaired as needed by servicing vendor as routine maintenance. Individual components can often be replaced for relatively low cost as an Operating expense. Plan for complete replacement at the approximate interval shown here for functional and aesthetic considerations.

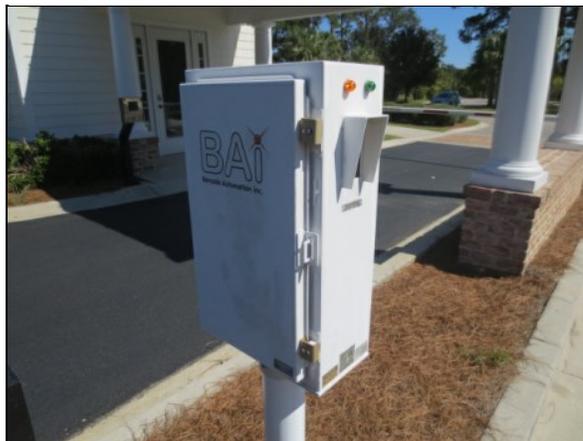
Comp #: 2507 Barcode Automation - Replace

Comments: Model# BA-200. Appeared weathered and manf date reads 2007. Although use has not been frequent replacement still may be required in the near future. Should be evaluated and repaired as needed by servicing vendor to ensure proper function. For best pricing and to minimize downtime, best practice is to replace with other similar components, such as gate operators. Cost shown is for the reader device itself; decals are assumed to be paid for by unit/homeowners. Plan on replacing at the approximate interval shown here.

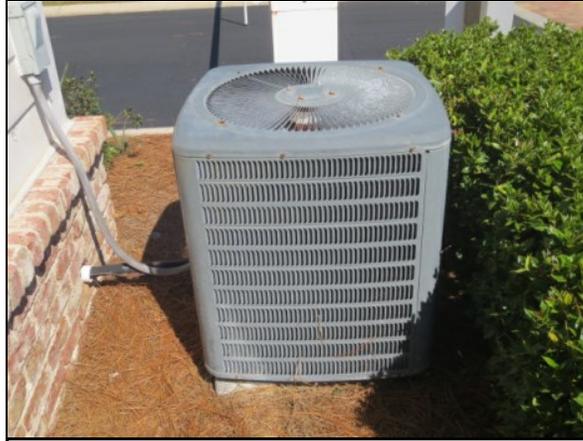
Comp #: 2522 HVAC (Guardhouse) - Replace

Comments: System was a Goodman model with 1.5 nominal ton capacity showing 2007 manufacture date. When exact replacement date is unknown or unreported, age of the system is derived by manufacturer's serial number or date shown on equipment unless otherwise noted. Life expectancy of HVAC systems can vary greatly depending on many factors including location of the property, level of preventive maintenance, manufacturer, etc. We recommend that routine repairs and maintenance such as filter replacement, system flushing, etc. be budgeted as an Operating expense. Useful life can often be extended with proactive service and maintenance. Unless otherwise noted, funding for system with same size/capacity as the current system. For split systems, we recommend budgeting to replace the entire system (condensing unit and air handler) together in order to obtain better unit pricing and ensure maximum efficiency, refrigerant compatibility, etc. If additional costs are expected during replacement, such as for system reconfiguration or expansion, ductwork repairs, electrical work, etc. costs should be re-evaluated and adjusted as needed during future Reserve Study updates.

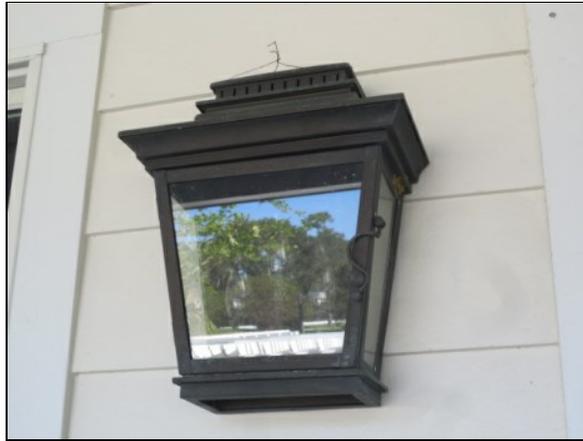
Comp #: 2303 Ext. Lights (Decorative) - Replace

Comments: Determined to be in fair condition typically exhibit more moderate signs of wear and age, but are generally believed to be aging normally with no unusual conditions noted. Observed during daylight hours, but assumed to be in functional operating condition. As routine maintenance, clean by wiping down with an appropriate cleaner, change bulbs and repair as needed. In general, costs related to this component are expected to be included in the Association's Operating budget. No recommendation for Reserve funding at this time. However, any repair and maintenance or other related expenditures should be tracked, and this component should be re-evaluated during future Reserve Study updates based on most recent information and data available at that time. If deemed appropriate for Reserve funding, component can be included in the funding plan at that time.

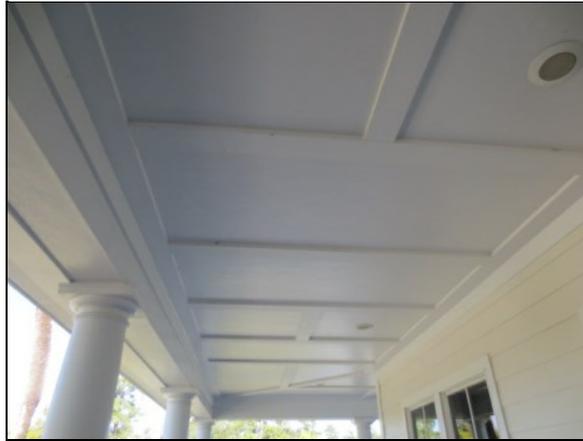
Comp #: 2304 Ext. Lights (Utility) - Replace

Comments: Recessed lights appeared to be in fair condition. Observed during daylight hours, but assumed to be in functional operating condition. As routine maintenance, clean by wiping down with an appropriate cleaner, change bulbs and repair as needed. Best practice is to plan for replacement of all lighting together at roughly the time frame below for cost efficiency and consistent quality/appearance throughout development. Should be coordinated with exterior painting projects whenever possible. Individual replacements should be considered an Operating expense. If available, an extra supply of replacement fixtures should be kept on-site to allow for prompt replacement.

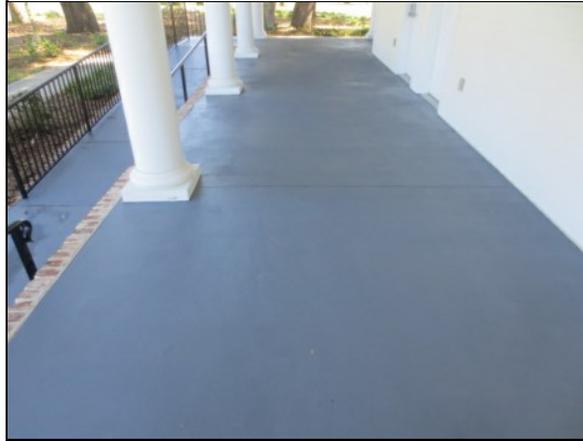
Comp #: 2315 Clubhouse Porch - Repair/Re-coat

Comments: Clubhouse house walkway deck was in fair to good condition. Surfaces are covered and should help protect these surfaces. Coatings determined to be in good condition typically exhibit generally uniform texture and color with little or no cracking, bubbling/blistering, peeling or other apparent physical deterioration. Coating is uniform and apparently providing adequate coverage to deck surface. Deck appears to be generally skid-resistant. Unless otherwise noted, specific brand/type of decking product in place was not confirmed. This component refers only to the top/finish coat unless otherwise noted. Whenever possible, decks should ideally be re-coated at the same time as building exterior painting or other exterior waterproofing projects to obtain better pricing and promote more consistent aesthetic standards. Future replacement may be needed if surfaces are not maintained. If this is the case funding should be added to future reserve studies.

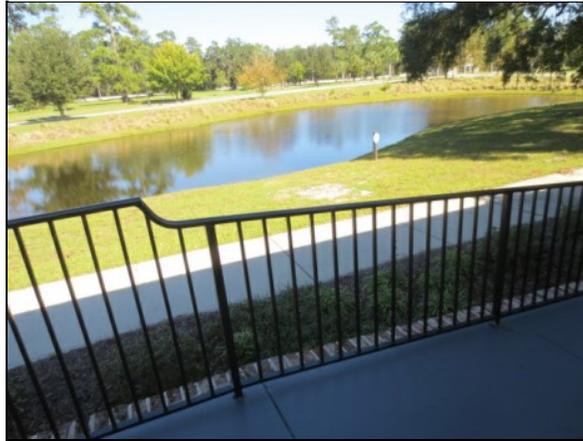
Comp #: 2326 Metal Handrails - Replace

Comments: Minor surface wear noticed. Post attachments and hardware should be inspected periodically for corrosion/rust and any waterproofing issues. As routine maintenance, inspect regularly to ensure safety and stability; repair promptly as needed using general operating/maintenance funds. We suggest Reserve funding for regular intervals of total replacement as indicated below. Unless otherwise noted, costs shown are based on replacement with a similar style of railing. However, if the Association chooses to upgrade or replace with a different style, costs may be substantially different. Any new information about changes in style should be incorporated into future Reserve Study updates.

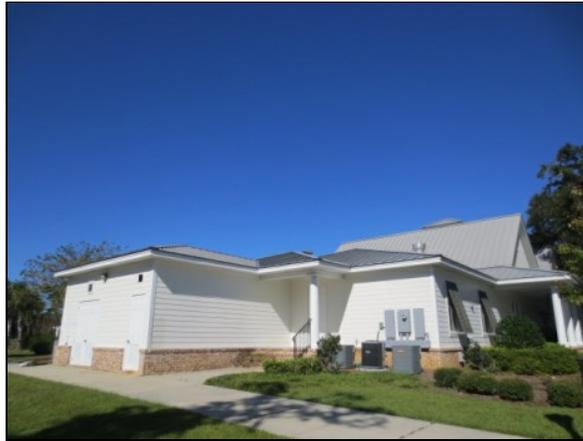
Comments: There are two important reasons for painting and waterproofing a building: to protect the structure from damage caused by exposure to the elements, and to restore or maintain good aesthetic standards for curb appeal. As routine maintenance, we recommend that regular inspections, spot repairs and touch-up painting be included in the operating budget. Typical paint cycles can vary greatly depending upon many factors including; type of material painted, surface preparations, quality of material, application methods, weather conditions during application, moisture beneath paint, and exposure to weather conditions. Proper sealant/caulking at window and door perimeters and other "gaps" in the building structure are critical to preventing water intrusion and resulting damage. The general rule of thumb is that sealant/caulking should be in place wherever two dissimilar building surfaces meet, such as window frame to concrete structure junctions. For best results, the client may want to consult with a paint company representative, building envelope specialist or structural engineer to specify the types of materials to be used and define complete scope of work before bidding. In our experience, cost estimates for painting and waterproofing can vary widely, even when based on the same prescribed scope of work. Estimates shown here should be updated and revised as needed based on actual bids obtained or project cost history during future Reserve Study updates.

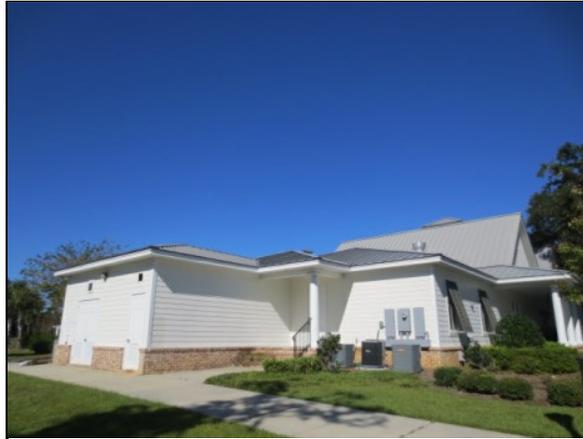
Comments: In most cases, small termite treatment projects are included within an association's Operating budget, but if significant damage or chronic problems become apparent, larger projects such as termite tenting may be required. Timing and scope of these projects are often unpredictable but once necessary, can become a recurring expense. This component should be re-evaluated during future Reserve Study updates based on recent cost history and vendor recommendations. A variety of treatment options are available and costs and schedule can vary greatly depending on type of treatment selected.

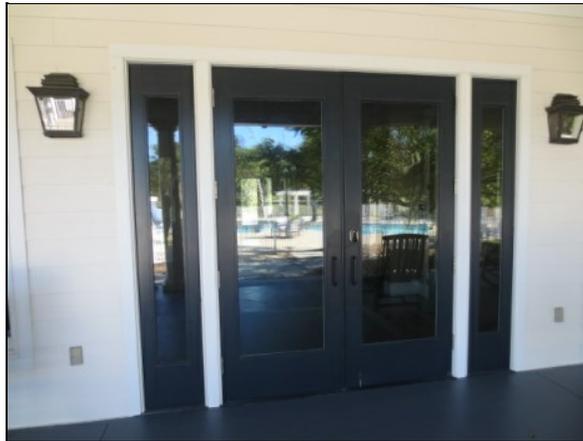
Comp #: 2367 Common Windows & Doors - Replace

Comments: There were (20) 3'x7' windows, (3) simple doors, (7) double glass doors. No issues were noticed or reported with water intrusion issues. All are assumed to have been compliant with applicable building codes at time of installation. Inspect regularly for leaks and cracks around frame and repair as needed. For operable windows, clean tracks and ensure hardware is functional to prevent accidental damage during opening/closing. With ordinary care and maintenance, useful life is typically long but often difficult to predict. Many factors affect useful life including quality of window currently installed, waterproofing details, exposure to wind and rain, etc. Individual windows and doors should be replaced as an Operating expense if damaged or broken. Plan for comprehensive replacement of all areas (unless otherwise noted) at the approximate interval shown here. Costs are based on replacement with good quality, impact-resistant models.

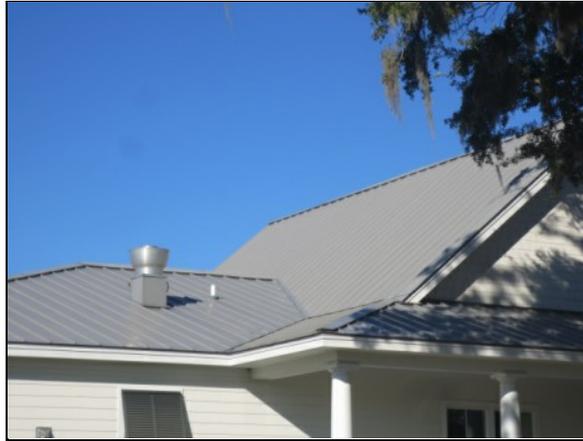
Comp #: 2384 Roof (Metal) - Replace

Comments: No issues were reported with water intrusion issues. The timeline for metal roof replacement is generally estimated based on the age of the roof. Remaining useful life can also be adjusted based on inspection of any accessible areas, looking for any damaged or lifting sections, signs of advanced corrosion or wear to panels and hardware, as well as consultation with the client about history of repairs and preventive maintenance. Advantages of metal roofs include long life expectancies with relatively low need to repair. Metal roofing is typically a long-lived component assuming it was properly installed and is properly maintained. As routine maintenance, many manufacturers recommend inspections at least twice annually and after large storm events. Promptly replace any damaged/missing sections or conduct any other repair needed to ensure waterproof integrity of roof. We recommend having roof inspected in greater detail (including conditions of sub-surface materials) by an independent roofing consultant prior to replacement. There is a wealth of information available through organizations such as the Roof Consultant Institute <http://www.rci-online.org/> and the National Roofing Contractors Association (NRCA) <http://www.nrca.net/>. If the roof has a warranty, be sure to review terms and conduct proper inspections/repairs as needed to keep warranty in force.

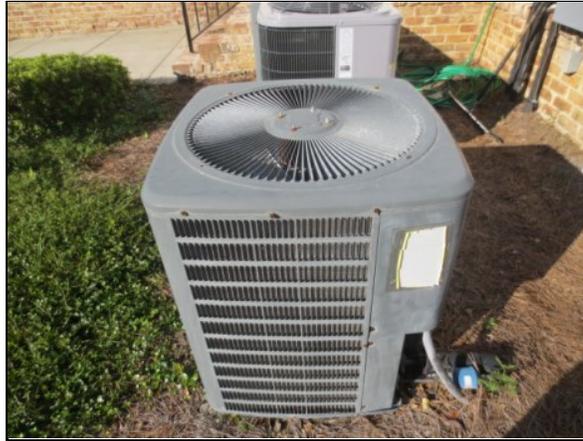
Comp #: 2524 HVAC (2007 Units) - Replace

Comments: These system are all original and replacement is expected in the near future. Systems were Goodman models with 2 and 3.5 nominal ton capacity showing 2007 manufacture date. If these are replaced one at a time they future reserve study should have them split out individually. There are two units of each type. When exact replacement date is unknown or unreported, age of the system is derived by manufacturer's serial number or date shown on equipment unless otherwise noted. Life expectancy of HVAC systems can vary greatly depending on many factors including location of the property, level of preventive maintenance, manufacturer, etc. We recommend that routine repairs and maintenance such as filter replacement, system flushing, etc. be budgeted as an Operating expense. Useful life can often be extended with proactive service and maintenance. Unless otherwise noted, funding for system with same size/capacity as the current system. For split systems, we recommend budgeting to replace the entire system (condensing unit and air handler) together in order to obtain better unit pricing and ensure maximum efficiency, refrigerant compatibility, etc. If additional costs are expected during replacement, such as for system reconfiguration or expansion, ductwork repairs, electrical work, etc. costs should be re-evaluated and adjusted as needed during future Reserve Study updates.

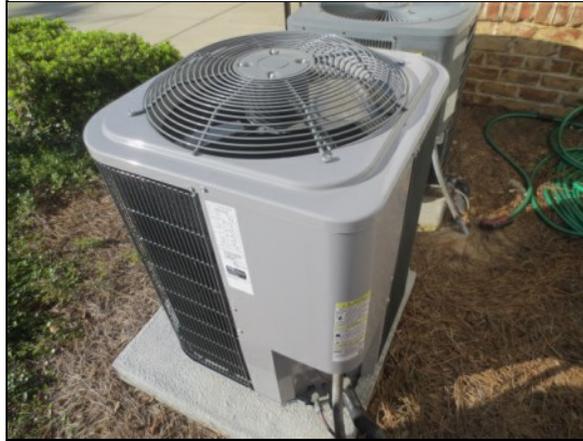
Comp #: 2525 HVACs (2017 Units) - Replace

Comments: These (2) Systems was a Heil model with 2 and 5 nominal ton capacity showing 2017 manufacture date. When exact replacement date is unknown or unreported, age of the system is derived by manufacturer's serial number or date noted on equipment unless otherwise noted. Life expectancy of HVAC systems can vary greatly depending on many factors including location of the property, level of preventive maintenance, manufacturer, etc. We recommend that routine repairs and maintenance such as filter replacement, system flushing, etc. be budgeted as an Operating expense. Useful life can often be extended with proactive service and maintenance. Unless otherwise noted, funding for system with same size/capacity as the current system. If additional costs are expected during replacement, such as for system reconfiguration or expansion, ductwork repairs, electrical work, etc. costs should be re-evaluated and adjusted as needed during future Reserve Study updates.

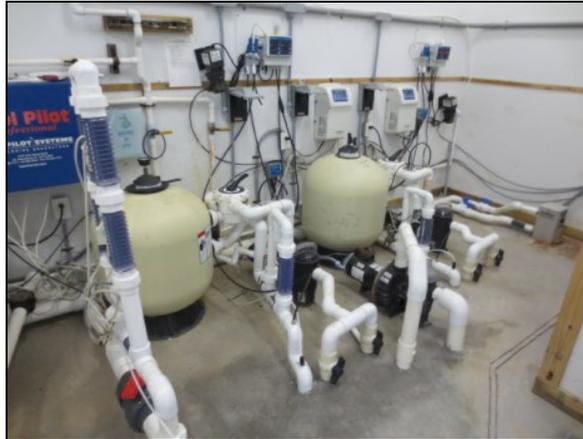
Comp #: 2779 Pool Filter - Replace

Comments: (2) Triton II TR 140C (2008) and (2) Triton TR 60 (2008). Pool vendor should inspect regularly for optimal performance and address any repairs or preventive maintenance as needed. Life can vary depending on location, as well as level of use and preventive maintenance. Plan to replace at the approximate interval shown below. Pool vendor should inspect regularly for optimal performance and address any repairs or preventive maintenance as needed. Life can vary depending on location, as well as level of use and preventive maintenance. Plan to replace at the approximate interval shown below.

Useful Life:
15 years

Remaining Life:
5 years

Lower estimate to replace

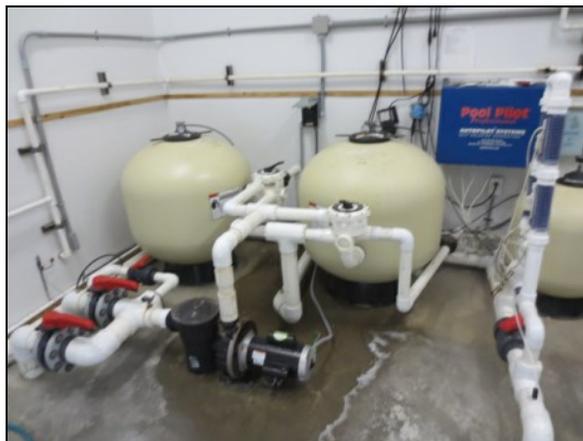
Comp #: 2783 Pool Pumps - Replace

Comments: (2) 1.5HP, (1) 3/4HP and (1) 5HP pump. Pumps should be inspected regularly for leaks and other mechanical problems. Cost shown is based on replacement with the same type and size unless otherwise noted, and includes small allowance for new piping/valves/other repairs as needed. Pumps should be inspected regularly for leaks and other mechanical problems. Cost shown is based on replacement with the same type and size unless otherwise noted, and includes small allowance for new piping/valves/other repairs as needed.

Useful Life:
10 years

Remaining Life:
5 years

Lower estimate to replace
